IN-DEPTH STUDY OF VOLVO CARS IN ROLLOVER ACCIDENTS

Åse Lund, Camilla Palmertz, Lotta Jakobsson, Göran Andersson
Volvo Car Corporation, Volvo Safety Centre, Göteborg, Sweden

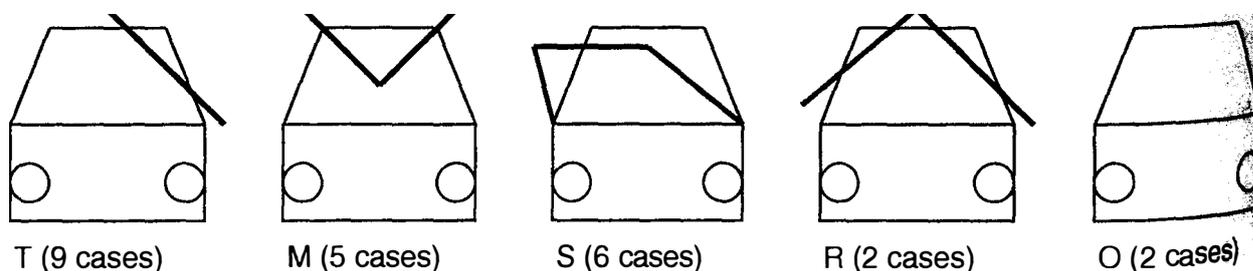
Figure 1. Deformation modes

Deformation modes and test method comparison Five deformation modes were chosen to characterise the car deformation. The principle for each mode is shown in Figure 1. Group O consists of two cars with undeformed roofs and pillars. Case U is not grouped into any mode since exterior photos were missing. Some of the cases are categorised in two modes. The mode for each specific case can be found in appendix 1.

In this sub set, the most common deformation mode is "T", followed by "S" and "M".

When compared to laboratory test methods (as identified in the previous chapter; Methods), 11 of the 21 in-depth cases could be described by a test method. The cases which had no similarity in deformation characteristics with a test method were the cases identified as deformation modes "M" and "R". Also some cases of "S" mode did not fit into a test method.

FMVSS216 is a very restricted test method, describing a specific impact location. None of the in-depth cases resulted in car deformation identical to FMVSS216. When applying the same test method, but with different angles and impact locations, several real life car deformations could be reproduced. Even when considering this modified test method, only 11 of 21 cases could be described by an existing rollover test method. Obviously, there is a great need for further test method development in order to evaluate all real life situations. Especially the identified M, R, and S modes, not found to be covered by existing rollover test methods.

Based on the shape of the roof deformation, only half of the cases analysed had a shape similar to that produced by published rollover test methods. Obviously, there is a need for further test method development in order to evaluate most of the real life situations. Especially the M, R, and S modes were not found to be covered by existing rollover test methods.

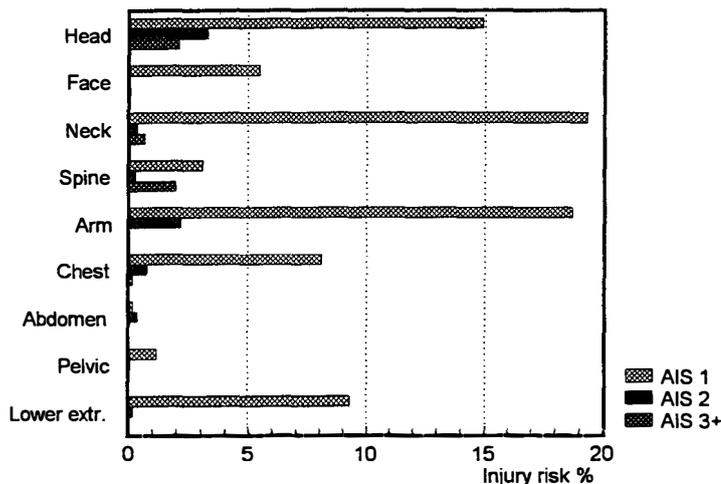
Figure. 2 - Injury risk for different body parts and injury levels. Note; the figure show MAIS per body part.

51% of the occupants were uninjured, 40% sustained MAIS1 injuries, 4.7% MAIS2 injuries and 4.3% MAIS3+ injuries. Body parts most frequently injured were head, neck and arm (also the highest injury risk of AIS1 injuries). Regarding AIS2 injuries the head and arm accounted for the highest injury risk, whilst for AIS3+ head and spine dominated.

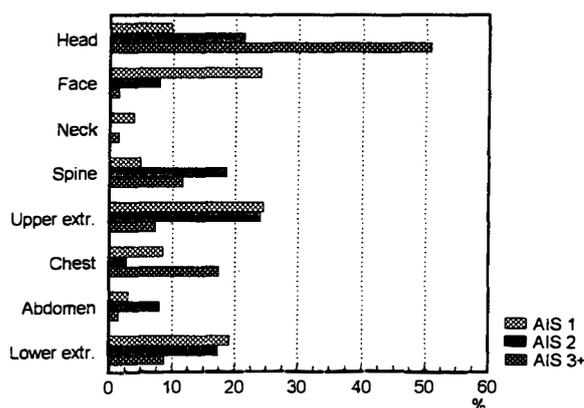
Figure 3. Distribution of body parts in the three different injury severity groups. Note that all injuries are included.

The injuries to the occupants are, in about 18% of the cases, MAIS 3+ injuries; mostly to the head, chest and spine. 15% are MAIS 2 injuries, dominated by injuries to the upper extremities, head, spine and lower extremities. Over 50% are MAIS 1 injuries. The most frequently injured body parts, receiving minor injuries, are upper extremities, face and lower extremities. 15% of the rollover occupants were uninjured. For the distribution of body parts in each injury severity group, see figure 3.
