**PASSENGER CAR CRASH WORTHINESS IN
MOOSE-CAR COLLISIONS**

89-2A-W-019

Presented at: The Twelfth International Technical
Conference on Experimental Safety Vehicles,
Göteborg, Sweden 1989

**P. LÖVSUND, G. NILSON, M.Y. SVENSSON, Chalmers University of
Technology**

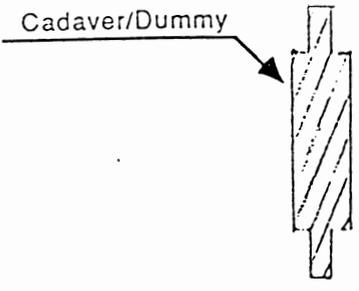
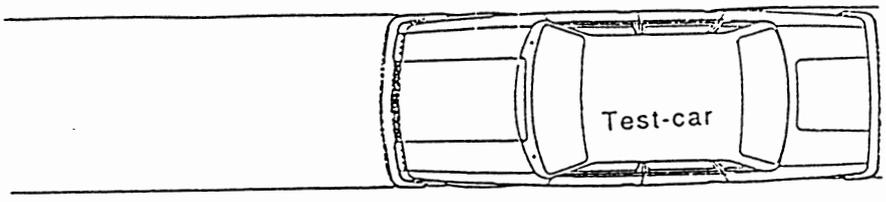
Figure 1: Test configuration.

The tests were made with an equivalent test set up. The mid plane of the car coincided with the center of mass of the moose-cadaver/dummy (fig. 1).

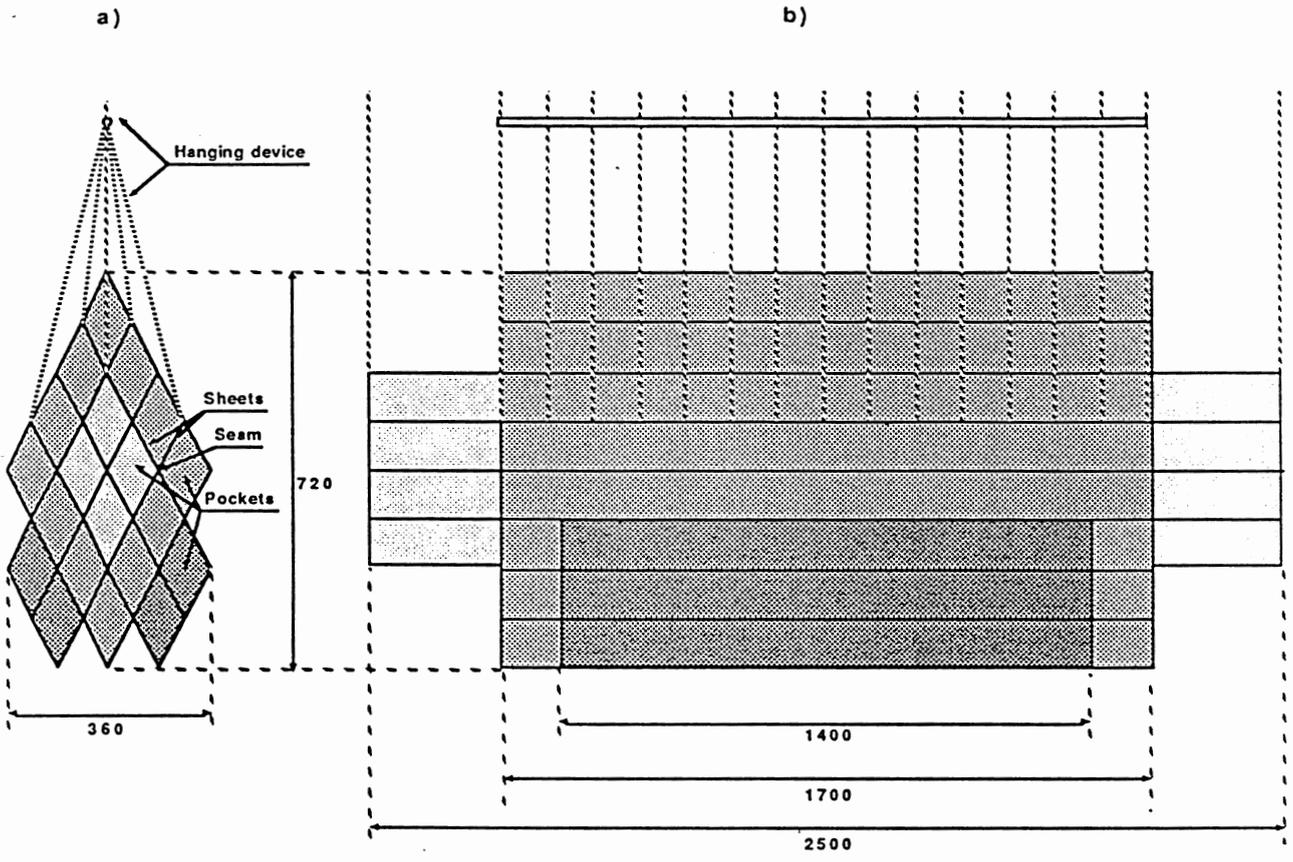
Figure 2 (above): a) Cross-section and b) sideview of the moose-dummy. Lengths in (mm).

The hoses were mounted together in a material matrix. The matrix consisted of a number of sheets of a knitted fabric (ENG-TEX AB, Y155) sewn together with a 6 mm wide flat-lock seam (fig. 2). The cross section of the dummy thus got a rhomboidal pattern. Each rhomboid "pocket" had a perimeter of 390 mm. Each hose was covered with a polyethene film to allow easy glide inside its pocket, which is essential in a bending motion of the dummy.

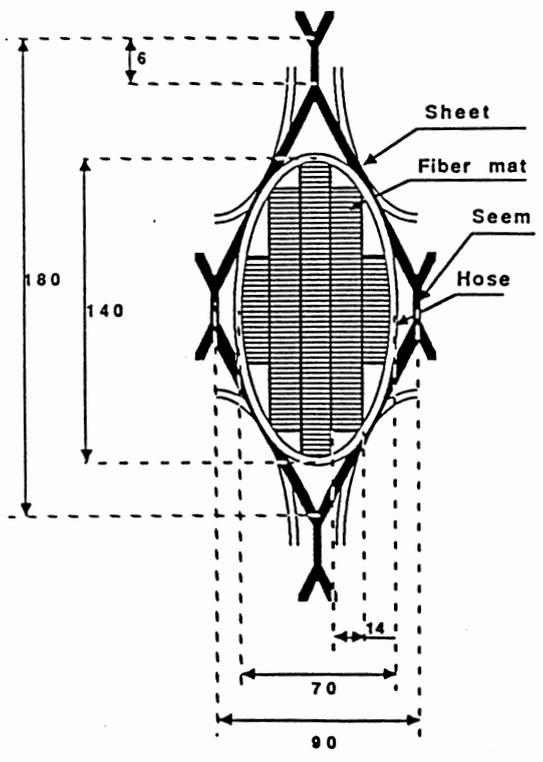
Figure 3 (left): Cross-section of one of the pockets with a hose in the dummy matrix. Lengths in (mm)

The hoses were tightened at the ends by welding and all air inside was removed. To avoid ripple inside the hoses they also contained five interlayers of a polypropylene fiber mat (ENG-TEX AB, Y065) (fig. 3). The mat consisted of two sheetings separated by thin, transverse, synthetic fibers which gave a high flow resistance.

To accomplish this we used hoses of different lengths (fig. 3).

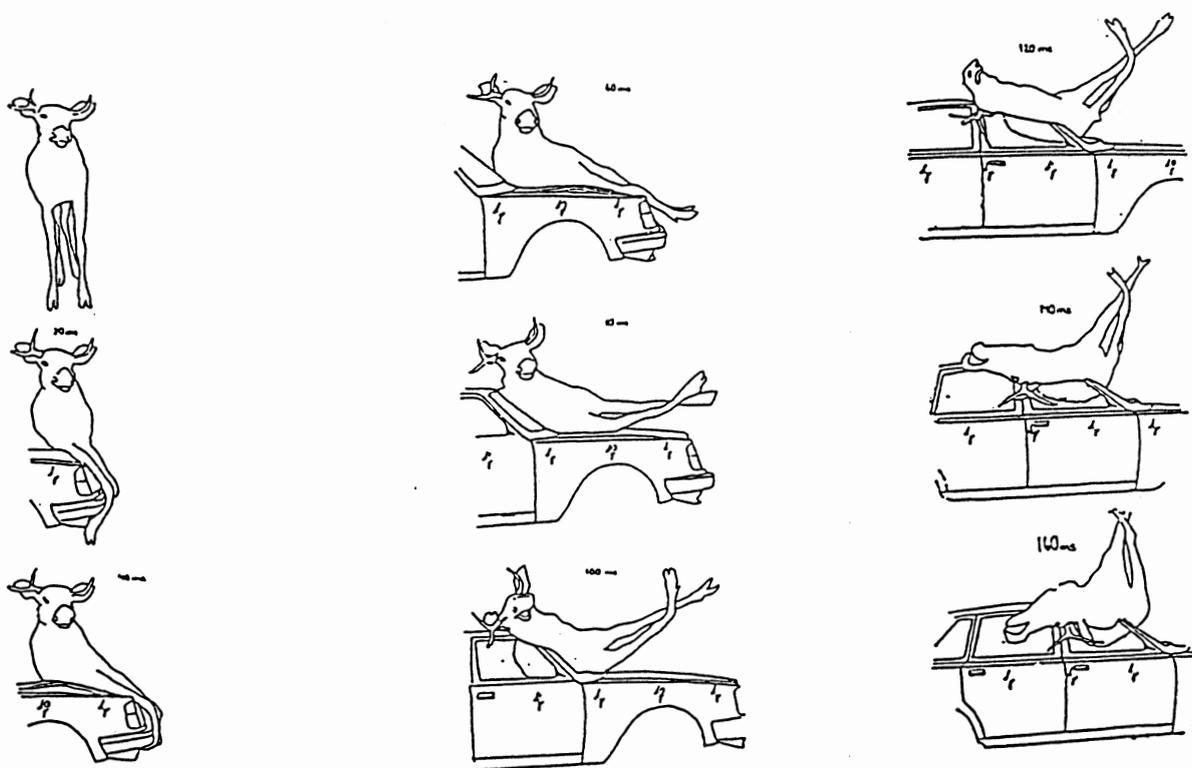
Figure 4: Drawings from the high-speed film of the cadaver-test showing the intrusion of the moose-body into the passengers' compartment. The first picture show first contact between the moose and the car, then each picture is drawn with a time interspace of 20 ms.

With this test setup the forelegs were hit by the car front, while the hind legs were passed. When the front hit the forelegs the hooves bent up under the bumper thus fixing the legs at this position during the first 50 ms after first contact. This forced the moose body downwards, towards the bonnet. Observations from the high speed films indicated that not much of the cadaver's mass was rotated in this initial sequence even though the superficial parts, the skin in particular, were considerably twisted (fig. 4).

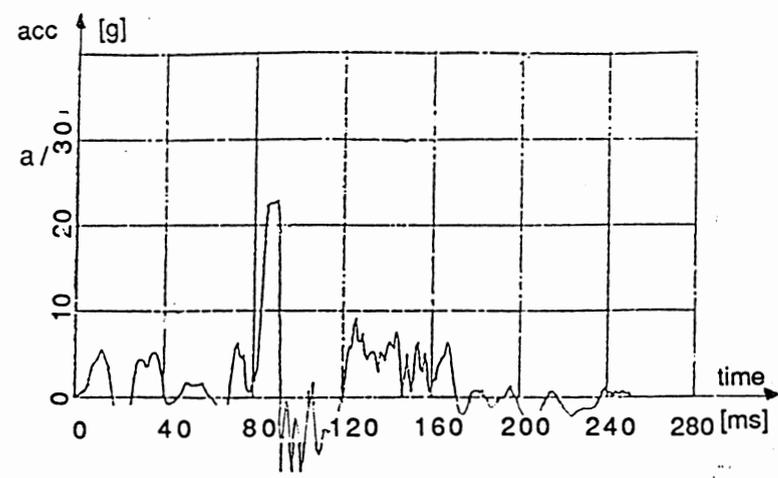
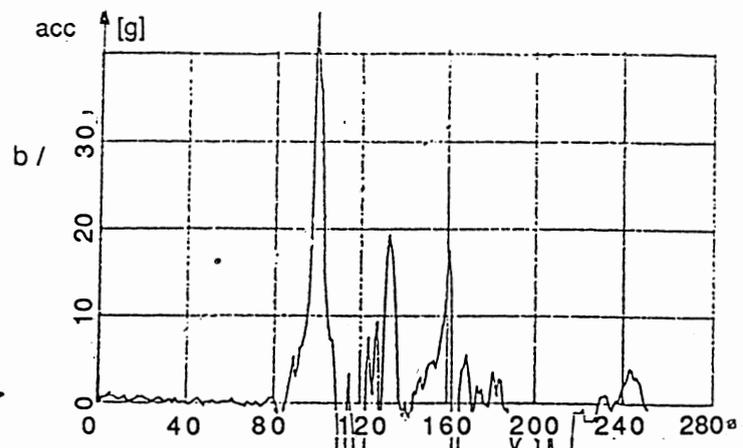
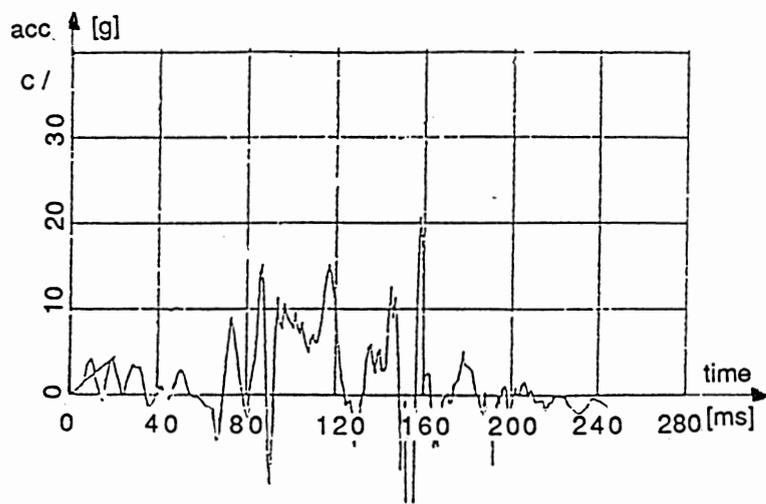
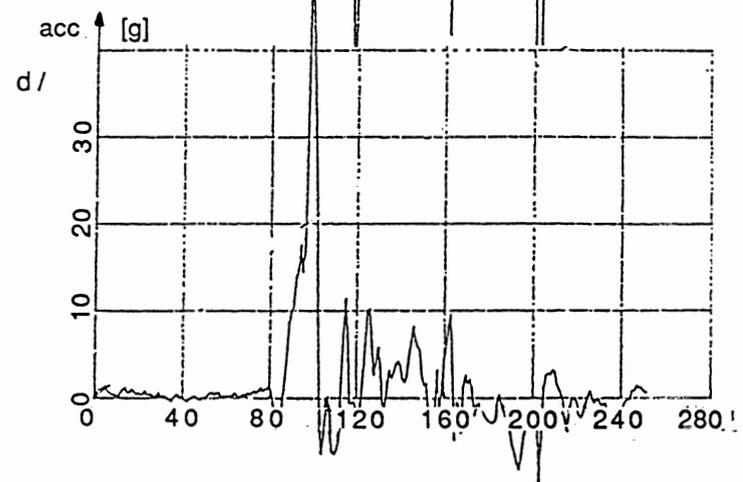
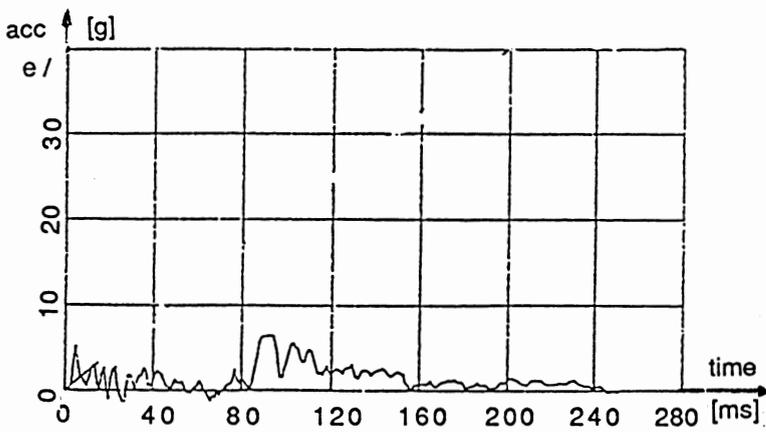
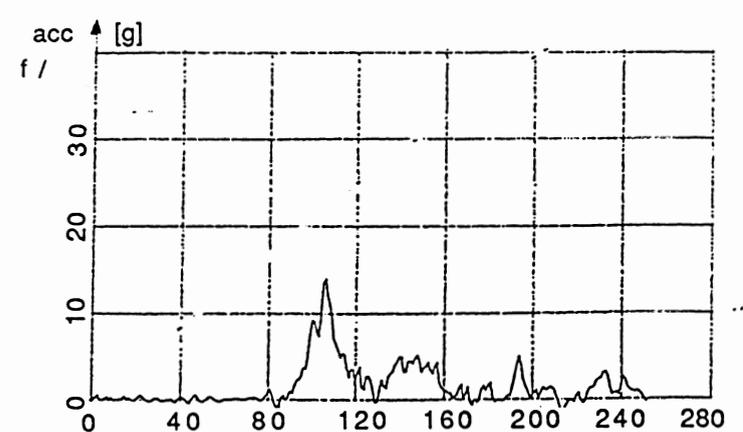
Figure 5, a-f: Accelerometer signals from the cadaver (to the left) and the dummy test. a/right b-pillar, cadaver test. b/right b-pillar, dummy test. c/left b-pillar, cadaver test. d/left b-pillar, dummy test. e/floor, cadaver test. f/floor, dummy test.

At approximately 80 ms after first contact the pelvis was hit by the right frontal part of the roof. This occurred at a speed of 76 km/h and induced a force peak of about 20 kN in the right force sensor and caused an acceleration peak of about 30 g at the b-pillar (figs. 5 and 6).

The force then rapidly decreased at the right side and slowly increased at the left side. The force pulse on the left side was lower but with a longer duration. The maximum value was about 14 kN (fig. 7). The impact had a duration of about 80 ms during which the car velocity dropped from 78.9 to 65.9 km/h, in complete accordance with the law of impulse. The pulses in the floor accelerometers never exceeded 10 g and had an average value of about 4 g (fig. 8).

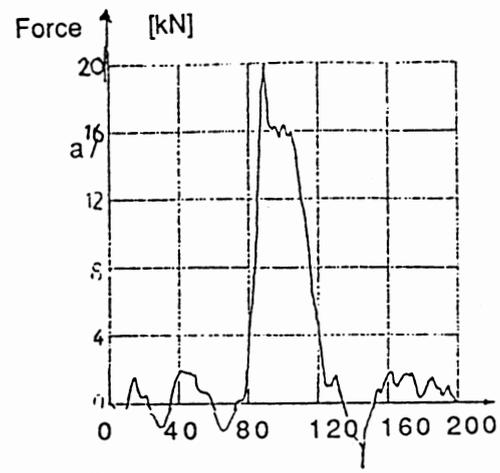
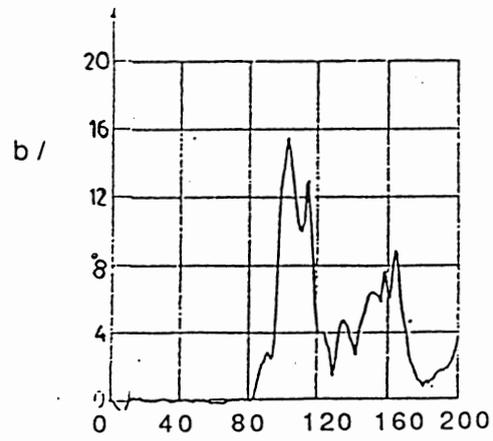
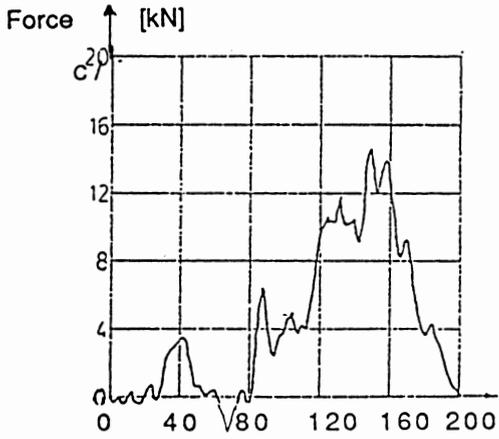
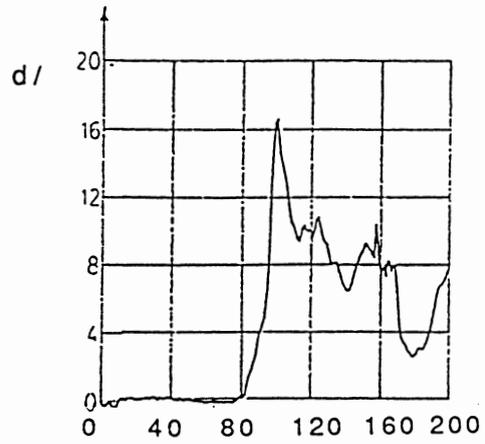
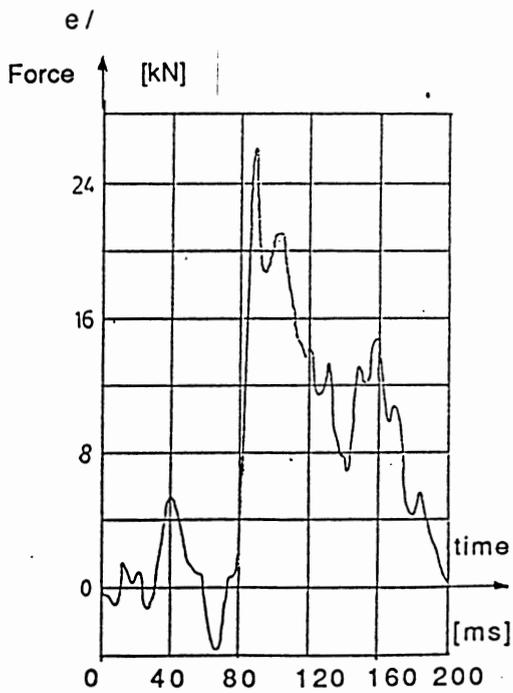
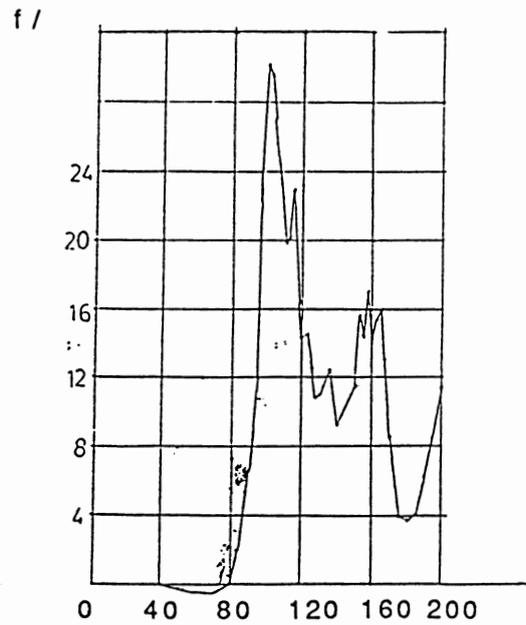
Figure 6, a-f: Force-sensor signals from the cadaver (to the left) and the dummy test. a/right b-pillar, cadaver test. b/right b-pillar, dummy test. c/left b-pillar, cadaver test. d/left b-pillar, dummy test. e/sum, cadaver test, f/sum, dummy test.

cadaver test. The acceleration and force pulses also showed good correlation (figs. 7 and 8).

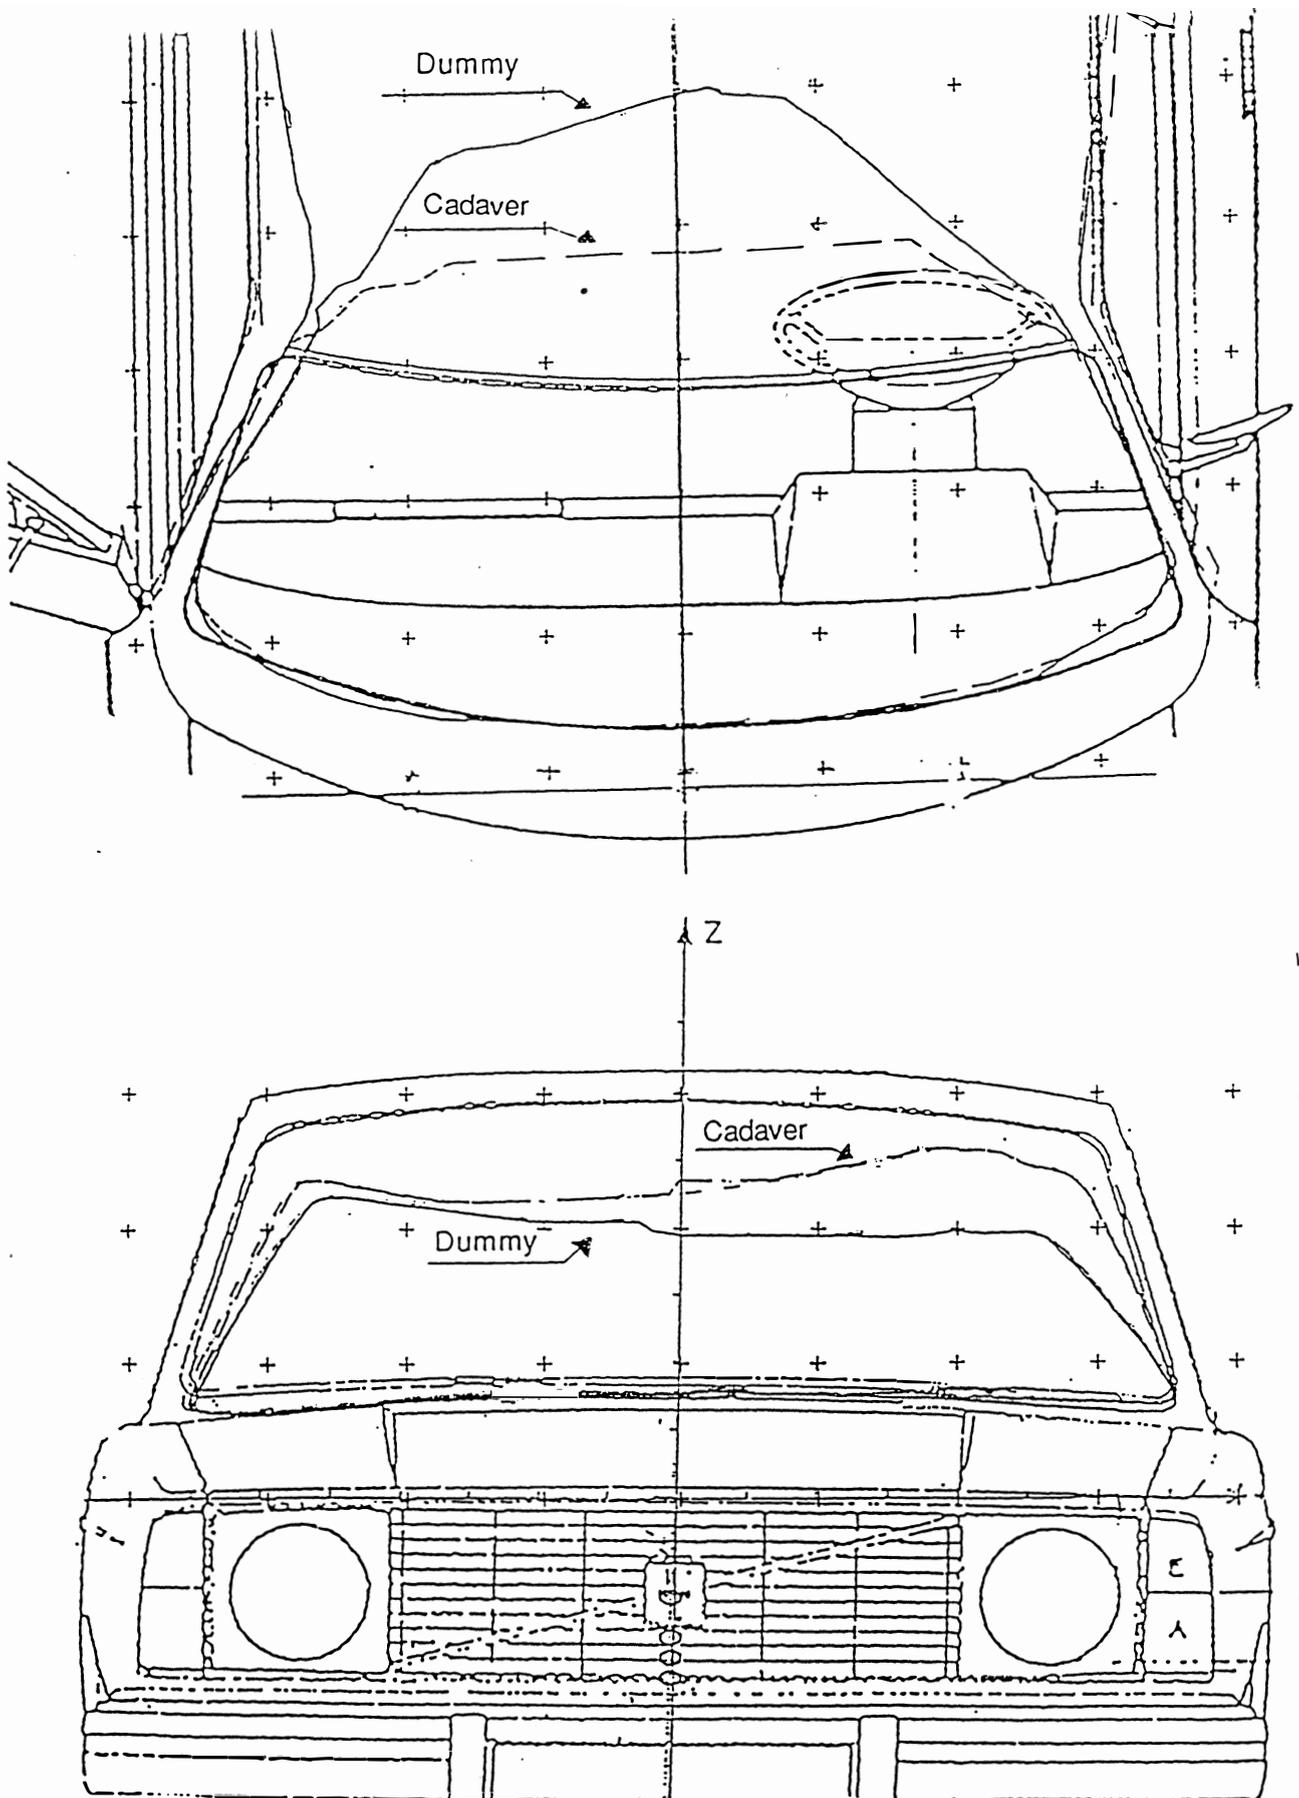
Figure 7: Residual deformations of the car in a horizontal (over) and frontal (below) plane.

The residual deformations of the car roof was up to 18 cm in the x-direction and 13 cm in the negative z-direction (fig. 9).

The impact speed was 76 km/h, corresponding to the windshield impact at the previous test. The residual deformations of the car roof was up to 40 cm in the x-direction and 18 cm in the negative z-direction (Figure 9).
